## Axle Tube Case Study

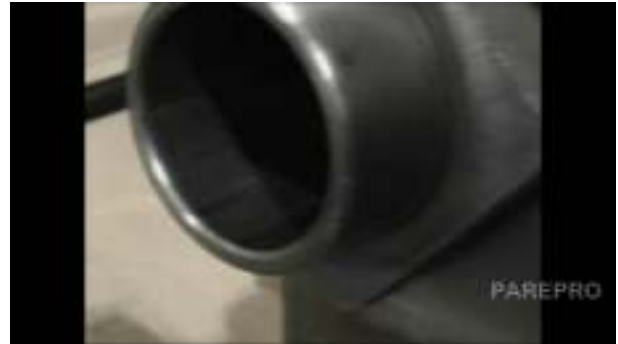
**Solution** - ParePro was applied to the ID of the tube which resulted in four (4), four (4) inch scribe lines covering the machining length on the tube. The tube surface scribe depths ranged from 1 – 4mm varying on the finished cut geometry of the axle tube. By ParePro pretreating the axle tube prior to the machining operation enabled the manufacturer to use existing equipment without any capital cost changes.

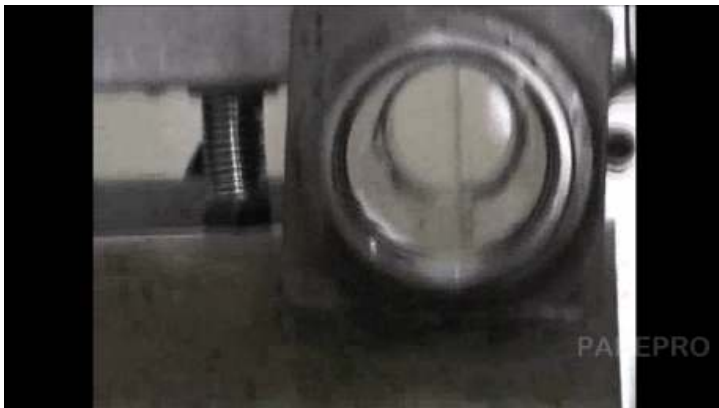
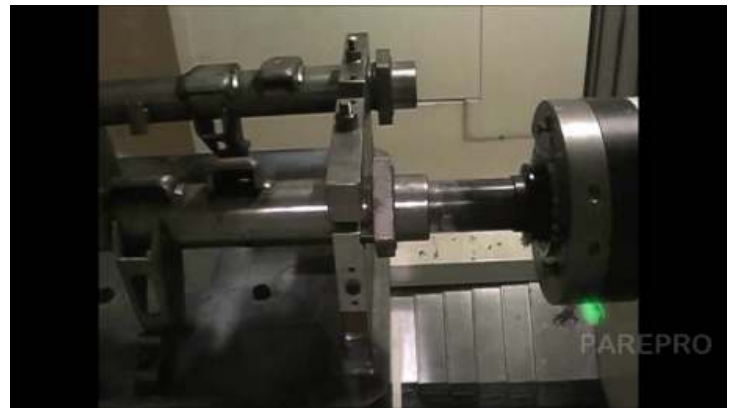
- **Reduced number of passes to one pass**
- **Cutting speed was increased**
- **Eliminated secondary debris removal operation**
- **Net saving of 43% machining time**
- **Able to run without coolant**
- **Increased production on existing equipment**
- **Increased safety for operator**
- **Longer use of tooling**
- **Reduced cost of this operation by 27%**
