Torque Converter Case Study

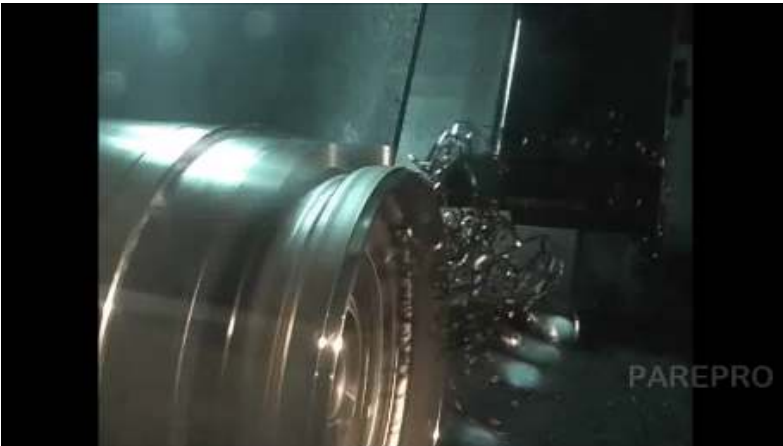
Challenge - A truck manufacturer had trouble keeping scrap metal stringers off of the tooling and out of the stamping when they began to turn the finished surface. The issue created a loss of time and the need for a secondary operation to remove the chips. In addition, the stringer created a safety issue for the operator because of their sharp nature. The current production was 400,000 units a year and the issue was occurring on every part so the customer was having substantial lost time and potential for injury on the floor.

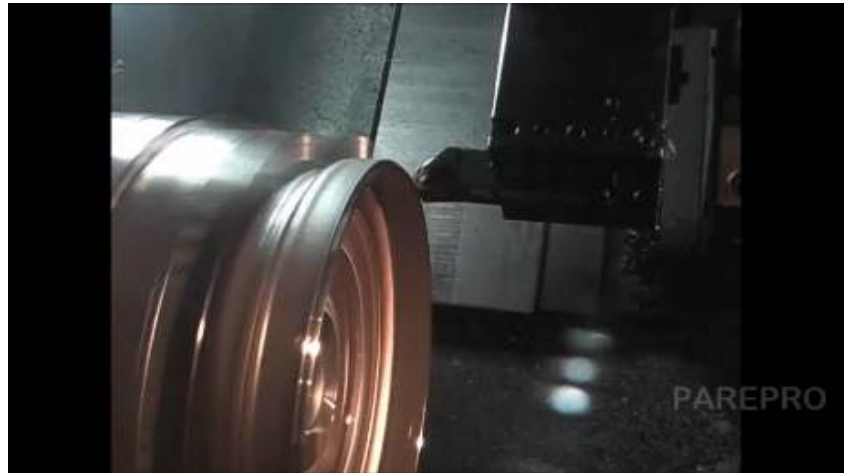
Solution – ParePro was installed and scribed in four (4) different areas on the part within the finished part parameters. ParePro cycle time was substantially less than the turning operation so ParePro was able to supply enough parts to feed multiple machining centers.
